RevMexAA (Serie de Conferencias), **24**, 107–112 (2005)

TESTING THE OPTICS OF THE INSTRUMENT ELMER

E. Sánchez-Blanco[1] and M. L. García-Vargas[1]

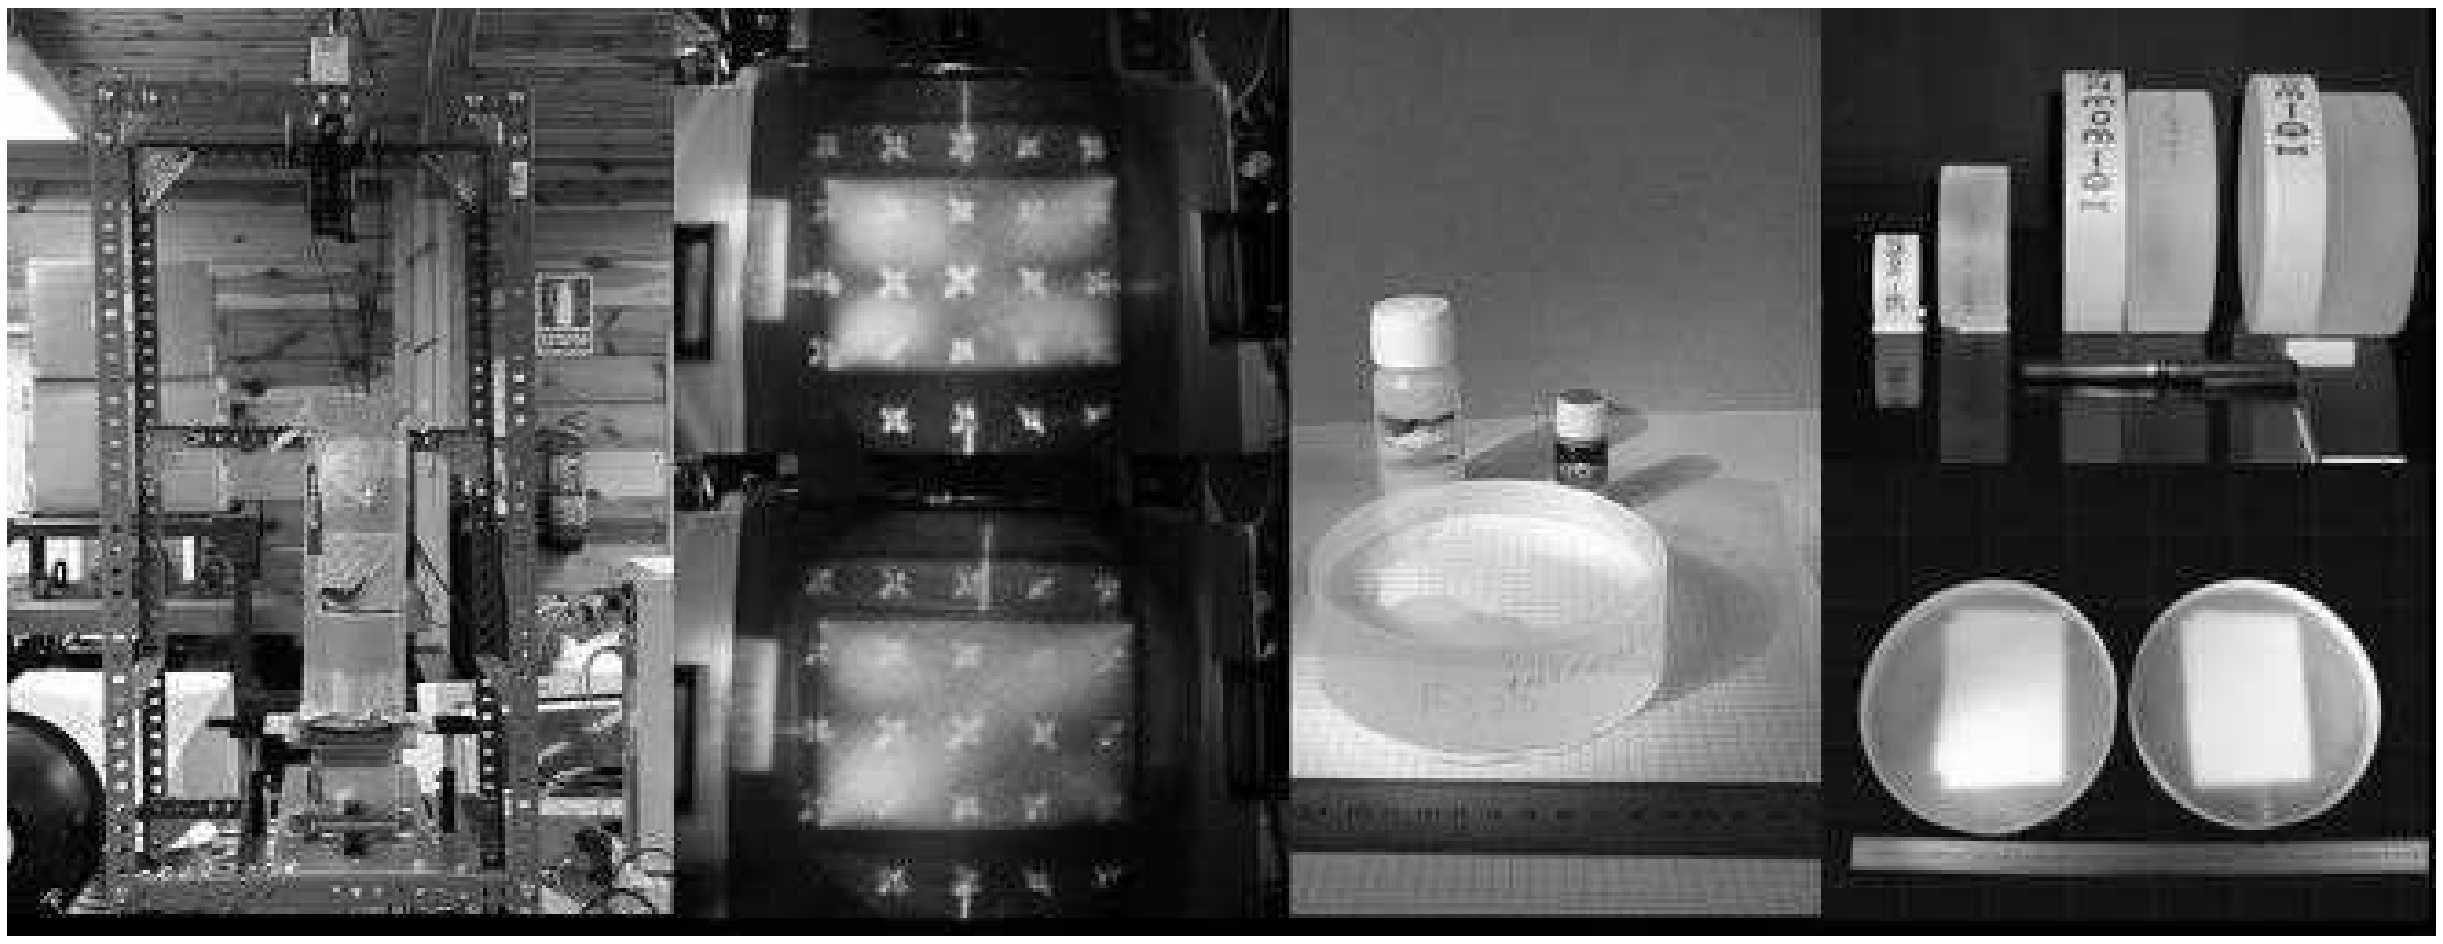
1. Inspection bulk tests, to look for bulk defects: absorption, inclusion, impurities, striae, and fracture. For the bulk tests, we used different oils to match blank index to allow inspection within the volume. We returned one blank to Schott Lit. due to its colored appearance.

Fig. 2. Picture on the left shows the full assembly for the birefringence test. In the middle, some raw images of a FSL5 120x120x90 mm blank. Picture on the right shows a CaF_2 blank while is being inspected using glycerin and the blanks of the camera (top right), collimator and field lens (bottom right).

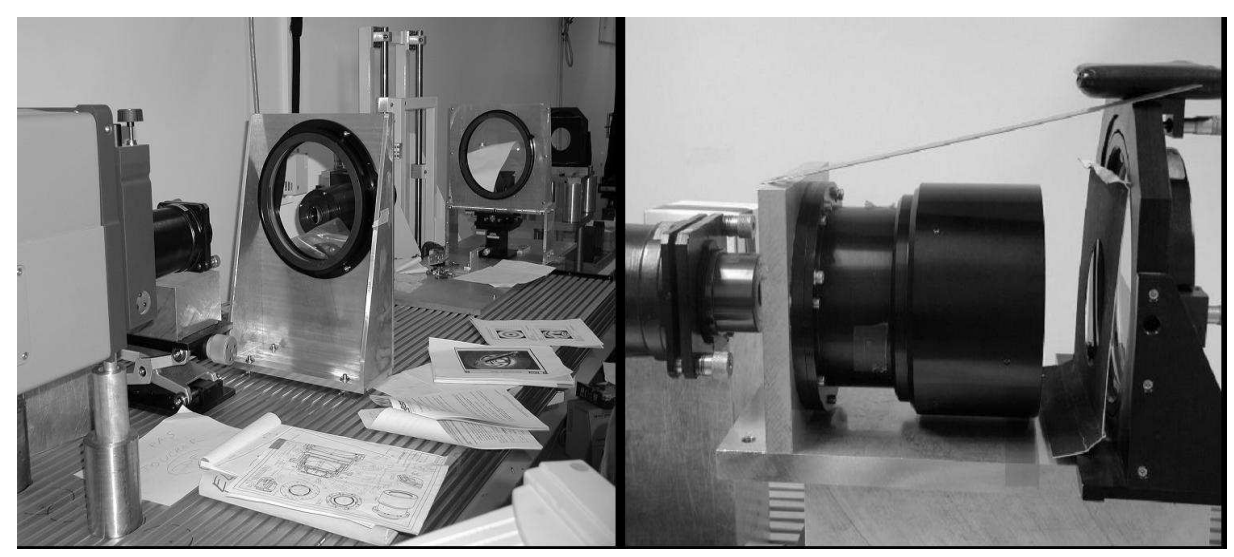
Fig. 3. Interferometric assemblies of field lens/collimator (left) and the camera (right) in SESO. All the WFE results were in specifications.

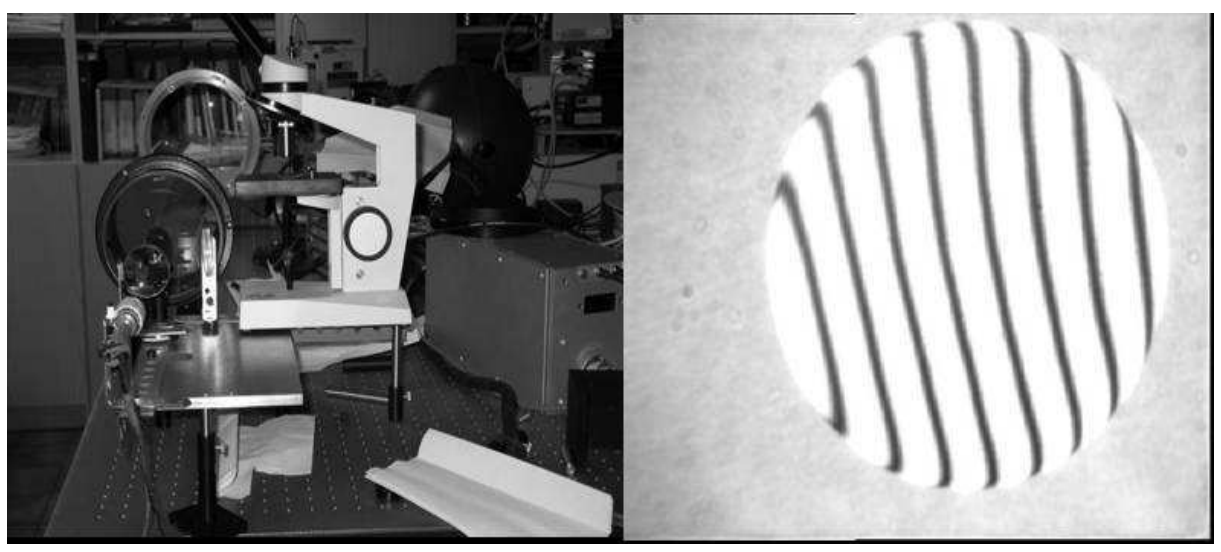
Fig. 5. Left, the assembly to measure the curvatures of the fused silica lens. On the right the interferogram supplied by INAOE for the concave surface.

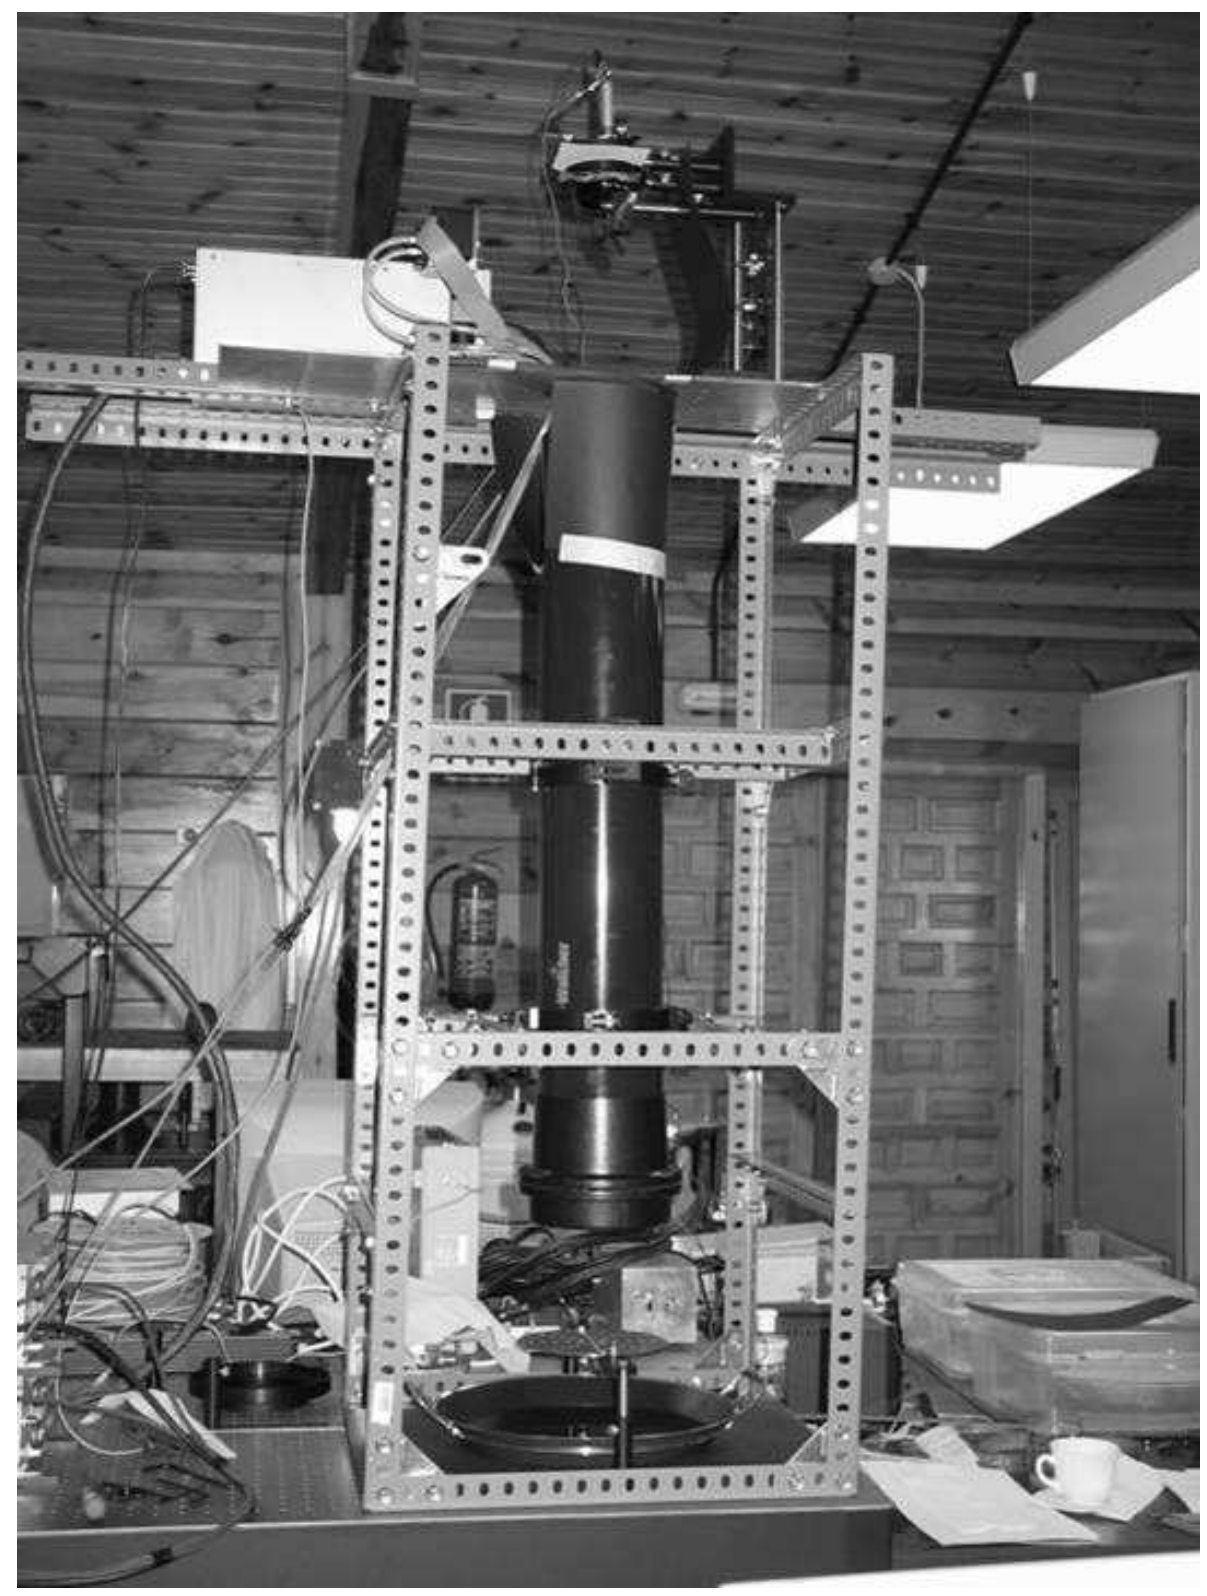
the filters we really could know the overall performance of each filter. Dominant aberration is focus (correctable thanks to the focusing mechanism on the collimator stage) and, after that, astigmatism and spherical aberrations (depending on the filter) dominates the errors. Some of the filters consumed more image quality budget than expected. Nevertheless the top requirements will be met since other elements are better than specified.

Fig. 6. Left, Hartmann assembly. The Hartmann had a beam of 150mm diameter and was placed vertically to have an oil surface at the bottom.

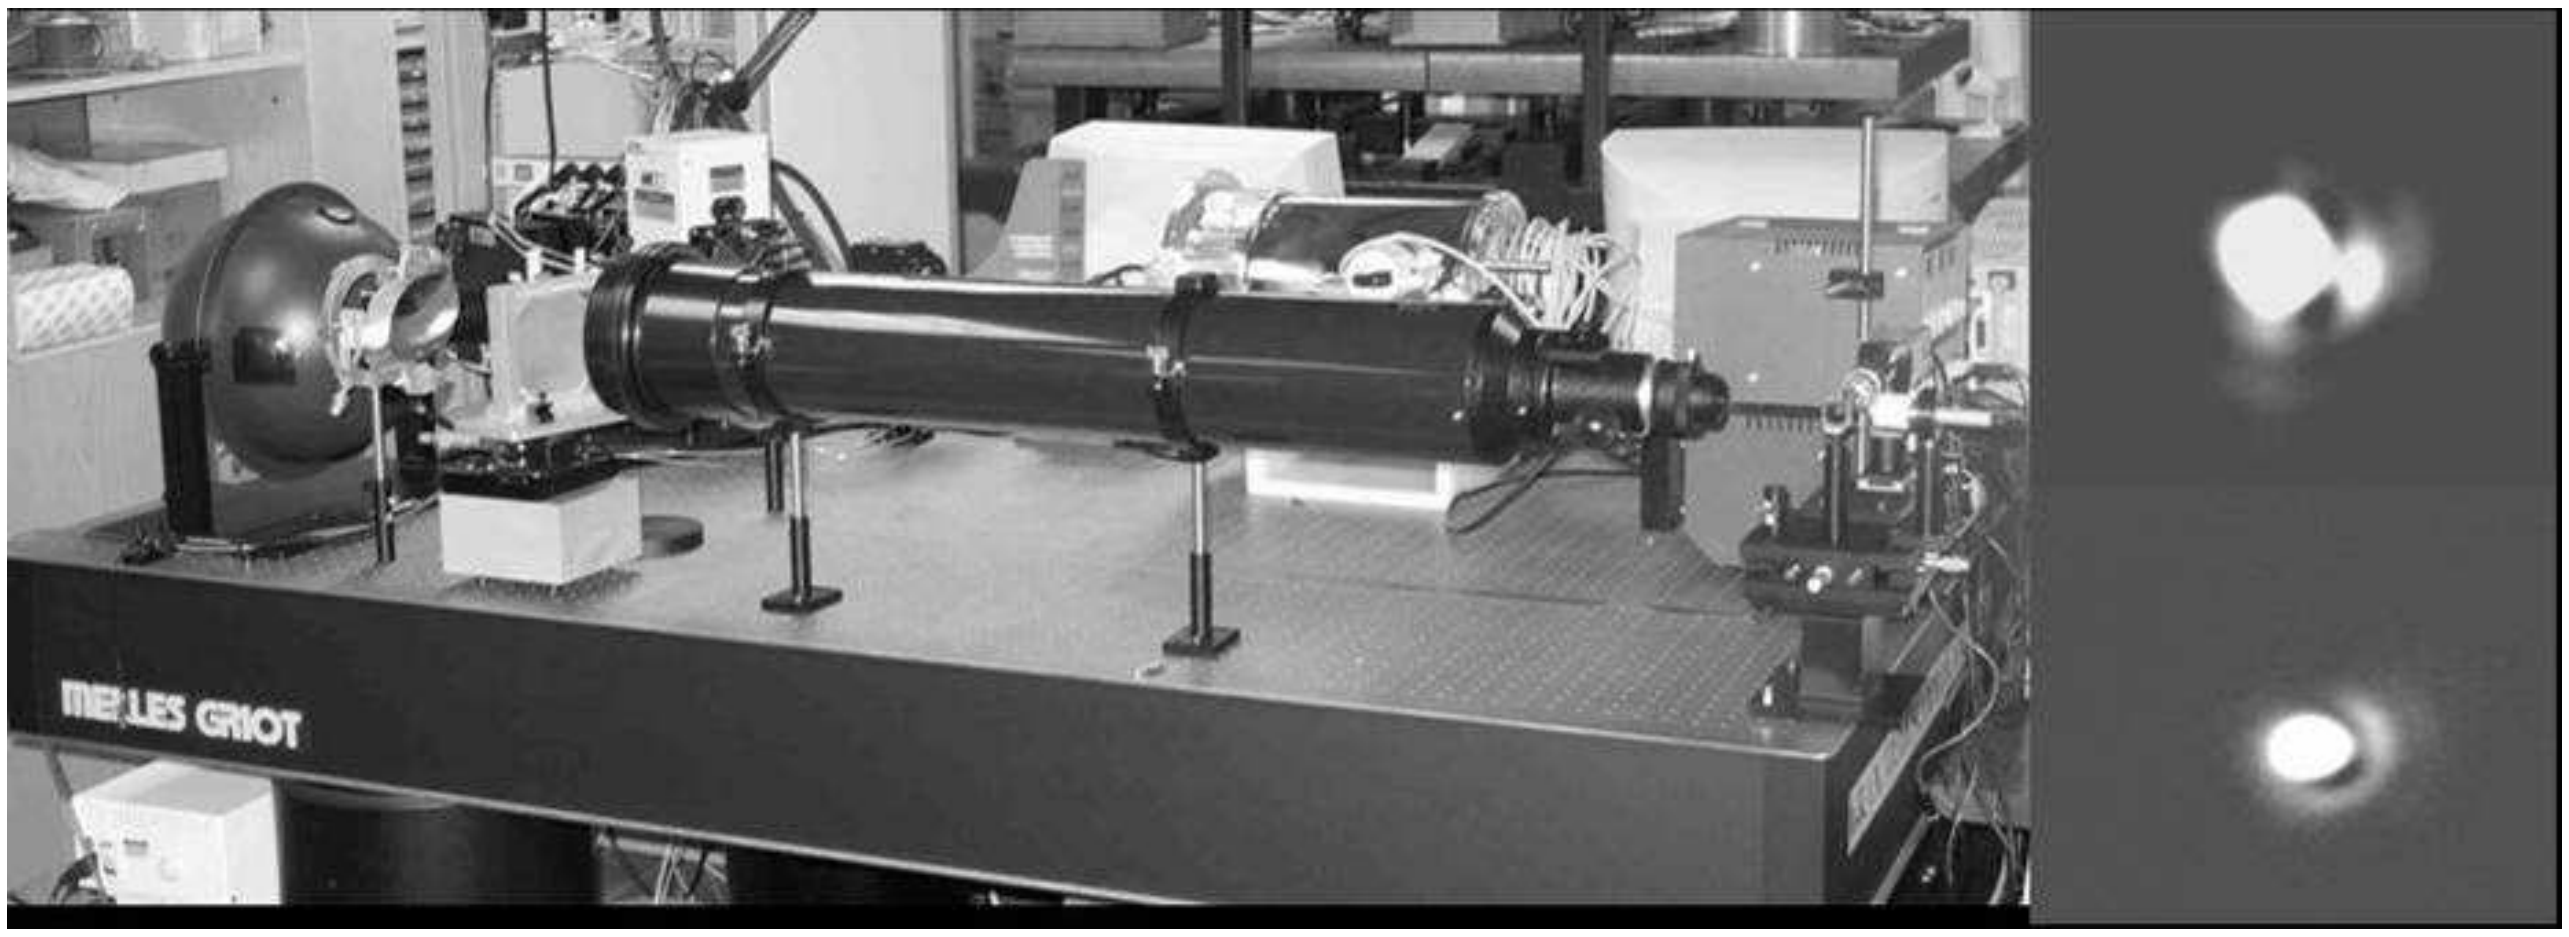
Fig. 7. Star test in double pass to measure the PSF degradation. The light goes from right to left, and is returned back by a flat mirror just next to the integrating sphere (not used in this test). On the right of the telescope a splitter cube feeds the light (diode laser beam with a spatial filter) and sends the returned beam to a microscope with a CCD. Right: PSF images before grating (down) and with the grating (up).

Two gratings were purchased to form part of the grisms (red and blue), once glued to the corresponding prisms. The PO supplied the windows of different sizes (previously polished and coated by INAOE) to the grating company (Richardson, RGL) to proceed with the replica. The acceptance tests regarding the gratings were: (a) verification of the number of lines/mm and the blaze angle, (b) the visual inspection of the replica for cosmetic defects detection and (c) the estimation of the transmitted WFE quality (by measuring indirectly the PSF with a microscope). The gratings were returned twice to the manufacturer. First time due to a replica in the wrong substrate and second time due to strong surface defects on the replica.

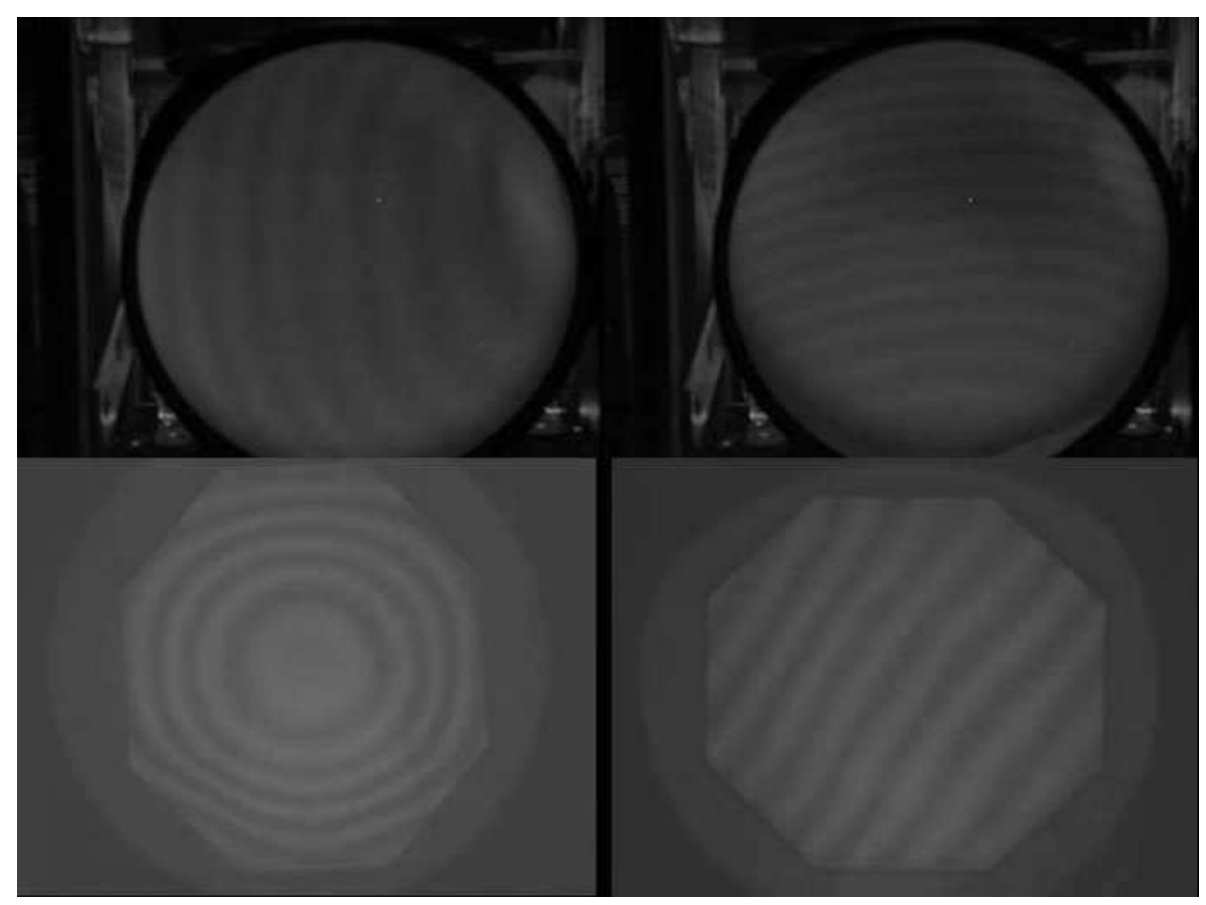
Prisms, grisms and VPHs have been designed at the PO. Blanks were bought, tested and sent to the polishers (INAOE, JANOS and SESO). Surprisingly for us some of the surfaces were nominally out of specifications although still valid using the best faces to air (once coupled). A simple Fizeau interferometer was assembled to verify surface quality, which sometimes was not provided by the manufacturers.

The real information about the surfaces permit the use of many of the surfaces nominally out of specifications without major degradation. This analysis also allowed us to understand the difficulties of the polishers with certain soft materials with high CTE.

Fig. 8. Top, ZnSe prism with severe turned down edge that is nominally out of specification. Bottom, window interferogram. The flat surface (around λ /8) was used to place the replica grating while the other side was cemented. This second surface was out of specification.

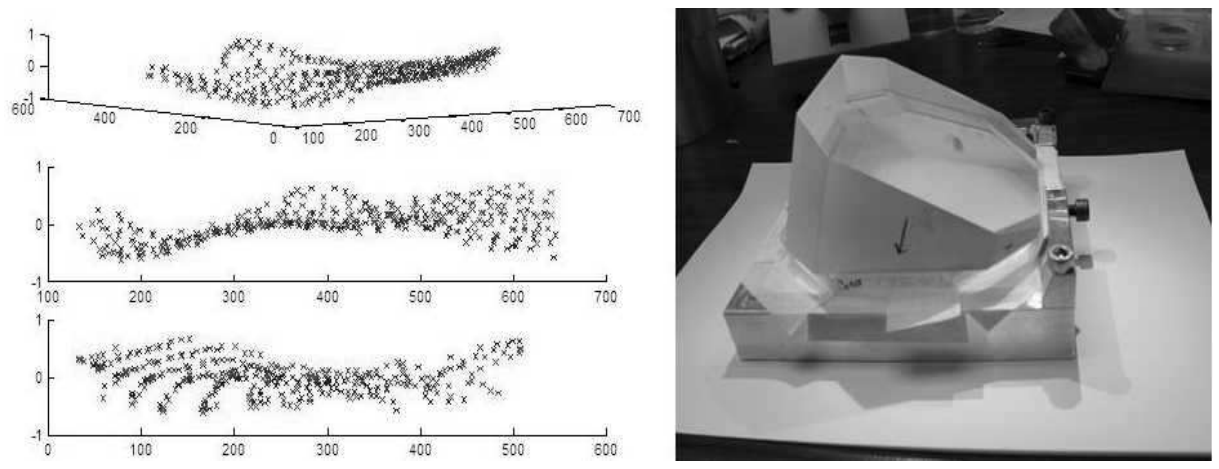
Fig. 9. On the left the wavefront surfaces in three views for some of the glue samples.The difference between the blue and the red surfaces are due to the glue.Tilt and focus were removed for both of them. Vertical scale is in waves units. The difference between the wavefront surfaces (one in red and the other one in blue)is not only due to the silicone but to the index mismatch and fringe positioning. In this sample the difference is under 30nm rms. On the right, the prism glued over the grating (replicated on a window, which is placed below the prism).
